Manhole Inspection Summary

Manhole # S55C__004MH

Insp Date: **6/23/08 8:25 AM**

Location Address: **3533 e fayette st**

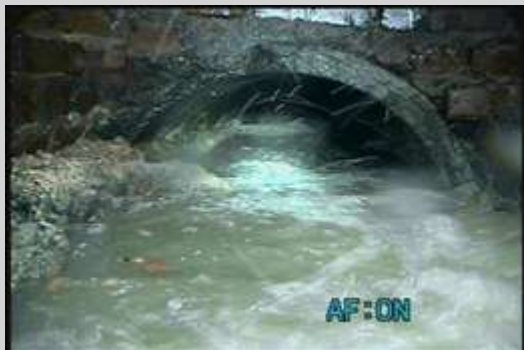
12 O'Clock Outflow

24 in. Circular Gravity Sewer
Pipe Out @ 12 O'Clock

Pipe Material: **Clay** ☐ Pipe Lined

Invert Depth: 10.15 (ft.) Flow Characteristics: **Fast**

Deposits: ☒ None ☐ Mud ☐ Sludge ☐ Debris ☐ Grease

Infiltration: **None** Pipe Seal Cond: **Unknown**

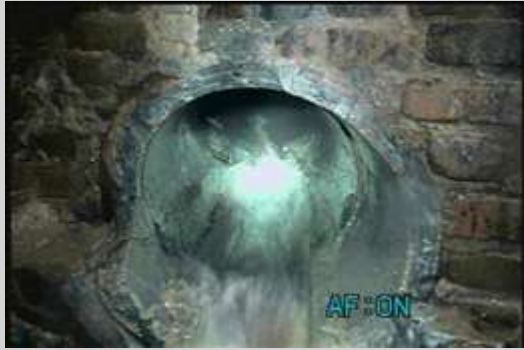
8 O'Clock Inflow

8 in. Circular Gravity Sewer
Pipe In @ 8 O'Clock

Pipe Material: Clay ☐ Pipe Lined

Infiltration: None
